Progressive Engineering Inc.

USA Vinyl LLC

ASTM D7032 Guardrail
Post Mount Tests

3/22/2018

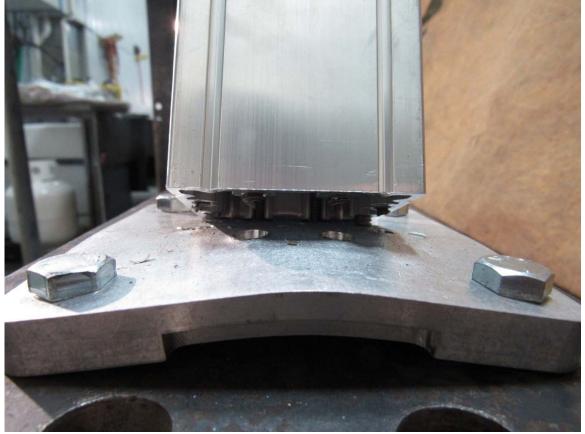
Post Test-1 Failure Picture

Test Results	Pass / Fail	PASS	PASS	PASS	
	Comments or Observations	or 60 lure d the on the	The sample held the required load for 60 seconds. Load increased until failure occurred. The screws which secured the post to the post base failed in tension on the opposite load side.	The sample held the required load for 60 seconds. Load increased until failure occurred. The screws which secured the post to the post base failed in tension on the opposite load side.	See attached charts for load versus deflection
	Deflection @ Max.	N/A	V/A	N/A	See attached
	Maximum Load Applied	847 lbf	873 lbf	834 lbf	3
	Deflection @ Design	0.849"	0.842"	0.789"	
ASTM D7032 Section 6 - Test Information	Required Deflection Deflection Maximum Ultimate @ Design @ Design Load Applied	3.50"	3.50"	3.50"	
	² Required Ultimate	500 lbf	500 lbf	500 lbf	
	¹ Design	200 lbf	200 lbf	200 lbf	
	Loading Location		42" Above Deck Surface	42" Above Deck Surface
