D7106.01-113-11-R0
ACOUSTICAL PERFORMANCE TEST REPORT
ASTM E 90 AND ASTM E 492

Series/Model: Flex Deck 90

Specimen Type: Sound Control & Crack Suppression Membrane

STC	63
IIC	62

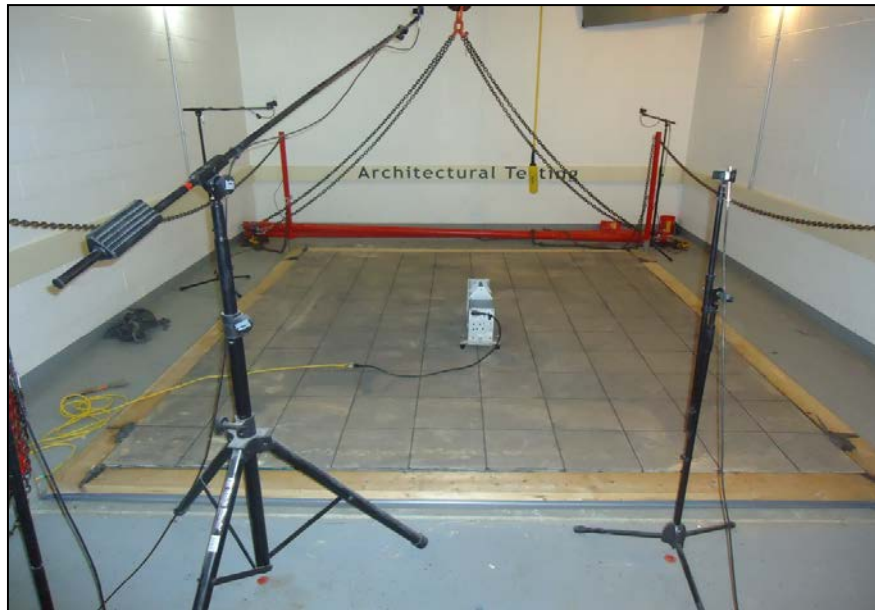
Source Room View of Test Specimen Installation

The ceramic tiles were set with light pressure into the bed of mortar and separated by 6.35 mm spacers. TEC Fast Setting mortar was mixed as per manufacturer's specifications and troweled on top of the underlayment using a 9.53 mm by 9.53 mm by square notch trowel. The mortar was allowed to cure according to the manufacturer's specifications. TEC Power Grout was mixed as per manufacturer's specifications and troweled into the 6.35 mm spaces between the ceramic tiles using a grout float. All excess grout was cleaned using a damp sponge. The grout was allowed to cure according to the manufacturer's specifications before testing. The perimeter of the ceramic tile floor was sealed to the test frame with duct seal.

A single layer of 0.05 mm self-adhesive polyethylene sheet was placed on the concrete. The Flex Deck 90 was placed onto the polyethylene sheet.

The concrete slab was installed into a test frame flush to the source room. The concrete slab was isolated from the test frame. The perimeter of the concrete slab was sealed with duct seal. Cure time for the concrete slab exceeded 28 days.

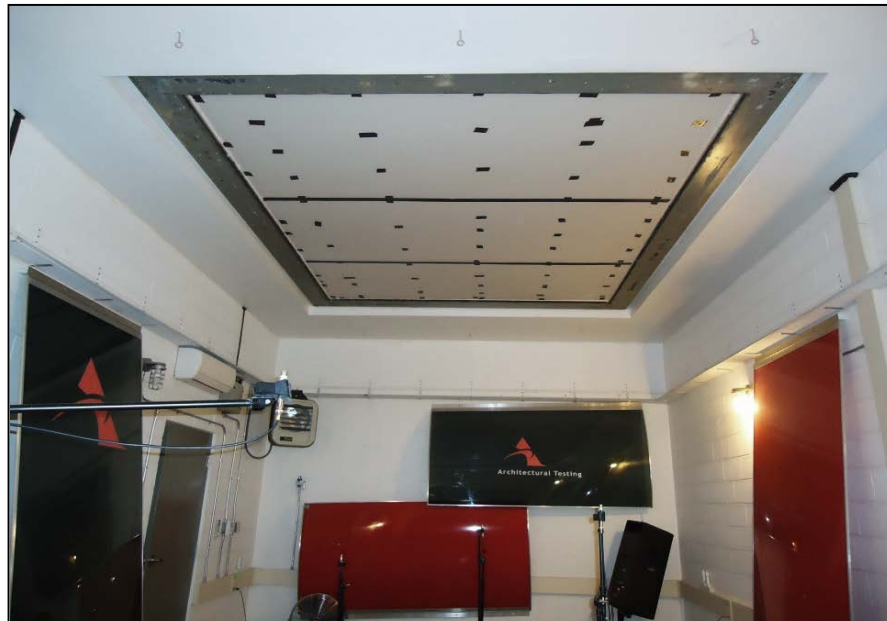
Receive Room View of Test Specimen Installation

Twelve gauge hanger wires were attached to the bottom side of the concrete with eye bolts at twelve locations. The hanger wires were twisted around the eye bolts a minimum of three times within 76 mm from the eye bolt. The hanger wire was bent and inserted into the HD8906 main beam and twisted around itself a minimum of three times within 76 mm from the main beam creating a 305 mm plenum. The XL8945P cross tees were inserted into the main beams on 406 mm centers.

A single layer of R-13 faced fiberglass insulation was loose laid onto the ceiling grid system. The Type X gypsum board was fastened with fine thread drywall screws on 305 mm centers. The perimeter of the gypsum board was sealed with acoustical caulk. The joints between the gypsum board were sealed with acoustical caulk and pressure sensitive tape.
