# KINGSTON

## INSTALLATION INSTRUCTIONS

### Twin Handles Wall Mount Faucet

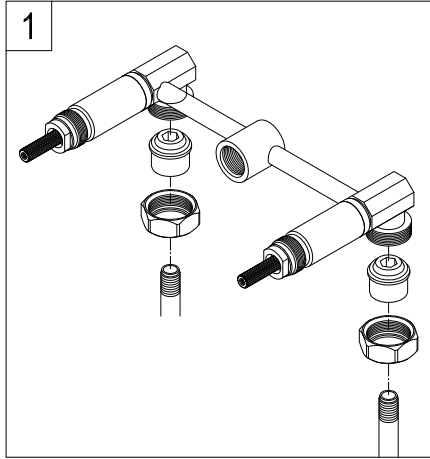
1. Properly secure valve body to wood bracing using copper straps (not included). Turn off water supply. Connect valve assembly to 1/2" supply lines. Tailpieces on valve assembly are threaded for 1/2" threaded pipe and will accept 1/2" sweat copper.

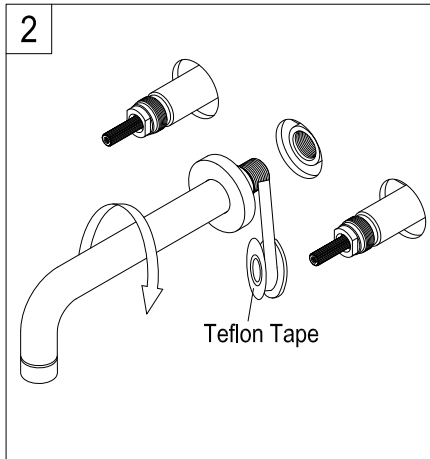
2. Apply Teflon tape to spout thread. Install spout to faucet body and tighten it.

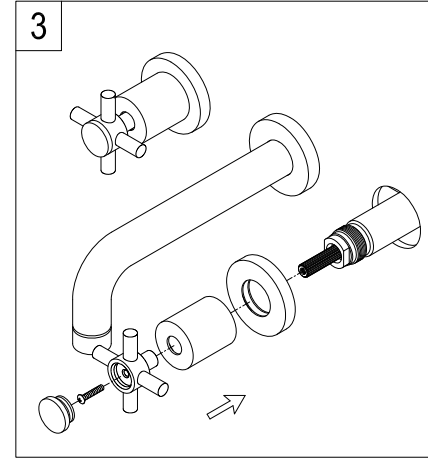
3. Push valve escutcheon over protruding valve assembly and secure with screws. Then replace handle.

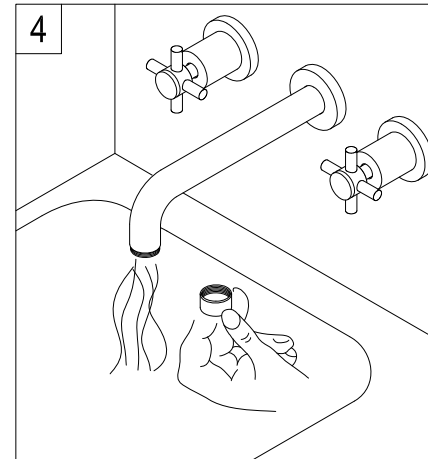
4. Remove aerator and turn on both hot and cold valves, let water run for at least one minute, this will clear any debris left in the line, reinstall aerator.
